Manhole Inspection Summary

Manhole # S47CC_060MH

Insp Date: **7/22/08 9:01 AM**

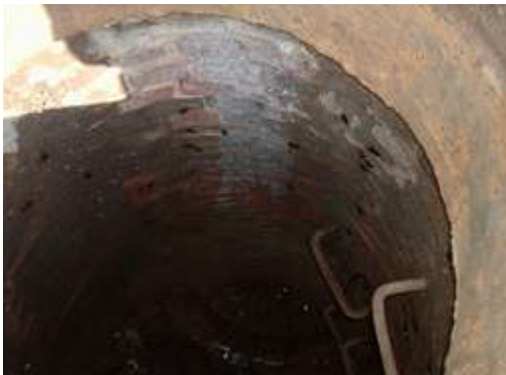
Defect 2

corrosion

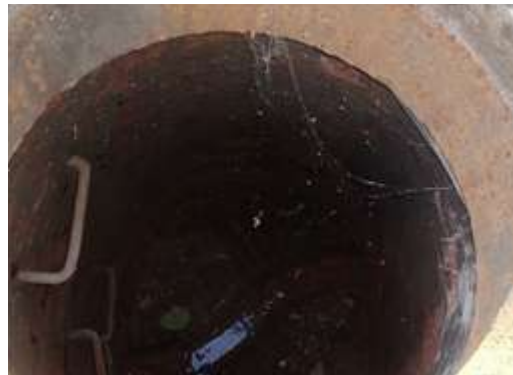
Defect 1

Infiltration: ☐ None ☐ Joint ☐ Cracks ☐ Mortar ☐ Roots ☒ **Wall**

infiltration

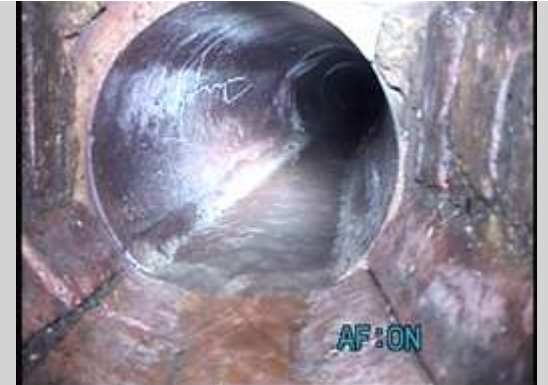
12 O'Clock Outflow

8 in. Circular Gravity Sewer
Pipe Out @ 12 O'Clock

Pipe Height: **8.4** (in.) Rod and Bar (Angled)
Pipe Material: **Clay** ☐ Pipe Lined
Invert Depth: **8.95** (ft.) Flow Characteristics: **Slow**
Deposits: ☒ None ☐ Mud ☐ Sludge ☐ Debris ☐ Grease
Silt Depth: (in.) Deposits Extent:
Infiltration: **None** Pipe Seal Cond: **Sound**

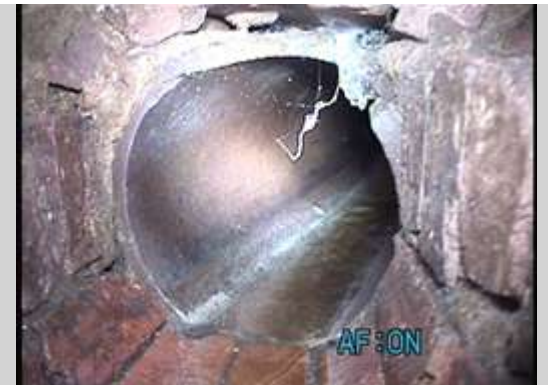
6 O'Clock Inflow

8 in. Circular Gravity Sewer
Pipe In @ 6 O'Clock

Pipe Height: **8.4** (in.) Rod and Bar (Angled)
Pipe Material: **Clay** ☐ Pipe Lined
Invert Depth: **8.75** (ft.) Flow Characteristics: **Slow**
Deposits: ☒ None ☐ Mud ☐ Sludge ☐ Debris ☐ Grease
Silt Depth: (in.) Deposits Extent:
Infiltration: **None** Pipe Seal Cond: **Sound**

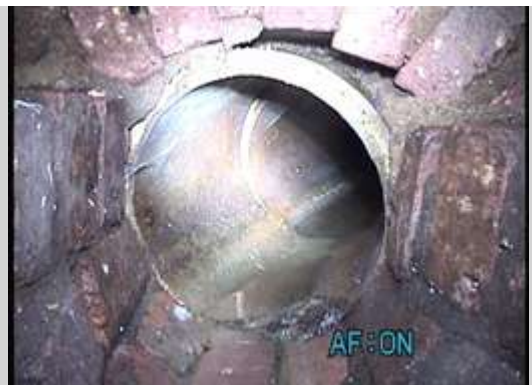
9 O'Clock Inflow

8 in. Circular Gravity Sewer

Pipe In @ 9 O'Clock

Pipe Height: **8.4** (in.) Rod and Bar (Angled)

Infiltration: **None** Pipe Seal Cond: **Sound**
